A monthly publication for GM Dealership Service Professionals

## TECH Link

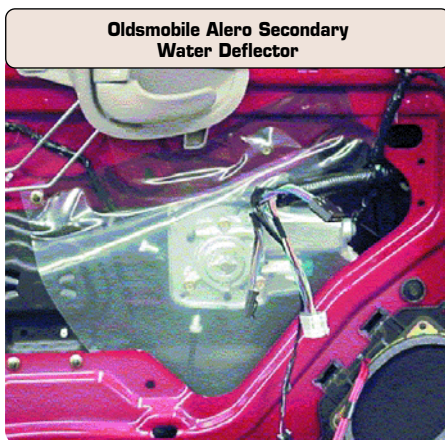
Oldsmobile Alero Secondary Water Deflector

Owners of some 1999-2001 Alero, Grand Am and Malibu models may comment about a mildew odor or wet carpet. This may be caused by voids, buckles or other areas

where the door water deflector is not properly adhered to the door.

Remove and discard the door water deflector. When removing the door water deflector for any reason, do not reuse it.

**IMPORTANT:** On the Grand Am and Alero 4-door models, install a secondary water deflector as shown in the photos before installing the main water deflector. At present, this secondary water deflector is

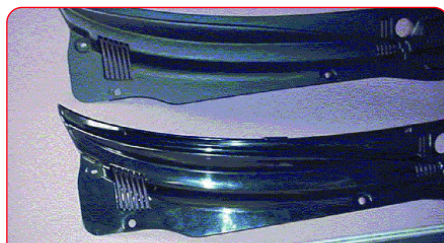
The captions on this photo were reversed in the Water Leak article on page 6 of the August issue.

With new style panel (top), use 25 mm foam.  
With old style panel (bottom), use 18 mm foam.
