A monthly publication for GM Dealership Service Professionals

Electrical Terminal Update

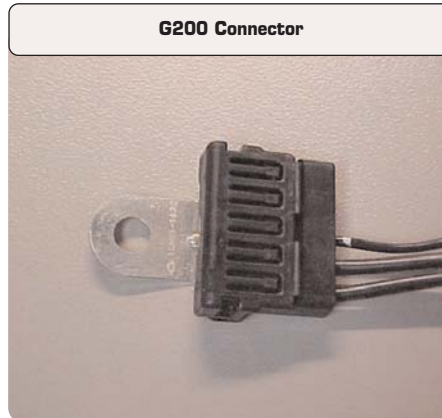
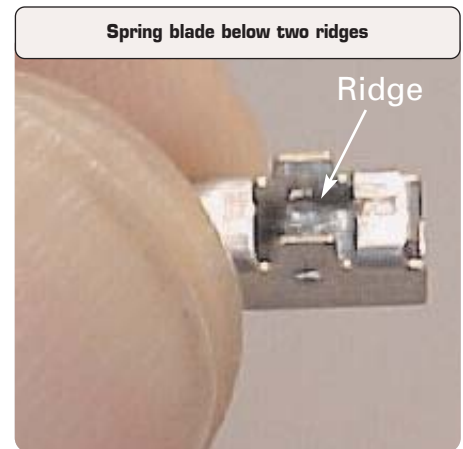
The likely cause for these combined malfunctions is the common ground, G200, which is located behind the driver side kick panel. The G200 ground is a silver colored metal tab, extending from a black plastic connector, which is screwed to the body. Remove the screw and release the tabs on the plastic connector, which will allow the silver tab portion to be removed.

At this point you can feel how well the wire terminals grip the common ground spades. If all the terminal ends are loose on their respective ground spades, the ground tab will fall out of the connector. Without proper tension, the circuits mentioned will

lose their ground. The dome light will illuminate when the door is opened because it will make a ground at each door switch.

Loose ground connections internal to the connector are caused during assembly by pulling on the wires while lining up and driving the fastening screw. The spring blades are pushed out and become stuck open, leaving no spring tension on the ground spades.

To correct the condition, remove the terminals and wires from their cavities, with an appropriate tool. Looking at the terminal, you can see the spring blade is stuck open, above two ridges in the terminal. Apply a light pressure to the back side of each spring blade, pushing it below the ridges, back into the original position, providing grip on the ground blade. Reinsert the ground spade to test the grip of the terminal. If it now functions correctly, reassemble the G200 ground and fasten it to the body in its original location.
