How to Find a Vehicle's RPO Codes

New J-45080 32MB Card for Tech2

GM TechLink is a monthly magazine for all GM retail technicians and service consultants providing timely information to help increase knowledge about GM products and improve the performance of the service department. This magazine is a companion to the GM Edge publication.

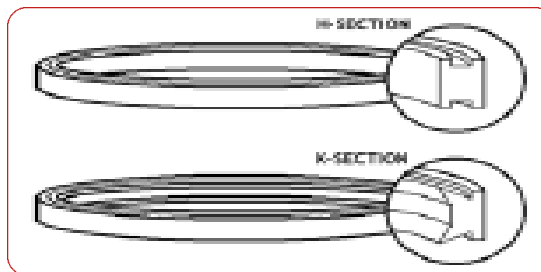
On some of these vehicles the customer will experience an illuminated SES lamp. Diagnosis will reveal a stored P0442 Evap code. The cause may be the seal between the fuel tank and the fuel gauge sender. If the seal is deformed and squeezed out, it can create a small air leak, causing the vehicle's self diagnostic to set the code.

The illustration shows the old seal with an H cross-section and

the new replacement seal with a K cross-section.

Replacing the seal should correct the condition. The seal has been manufac-

tured in two configurations, called the H cross-section and the K cross-section.

The H-seal was originally used in production, and the K-seal is the replacement. The part number for the K-seal is 22626099.

Follow the procedure in SI 2000 when replacing the seal.

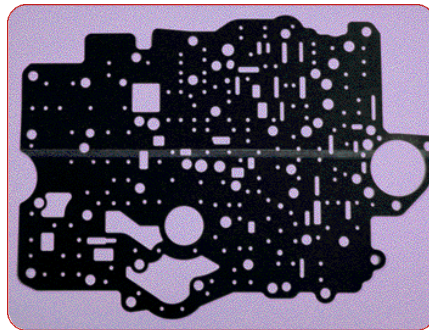
The customer may experience a harsh garage shift from park to reverse first thing in the morning or first shift of the day. This may be more prevalent in cooler weather. The condition will not repeat itself throughout the day but may return the following day. If the customer concern does not exactly match the above description, this step will not help and should be skipped.

Revised spacer plate gasket with white stripe

upper valve body spacer plate gasket has been developed to correct this condition. The part is currently available through Technical Assistance until inventory is available at SPO. A white colored stripe, running the length of the gasket can identify this new gasket.

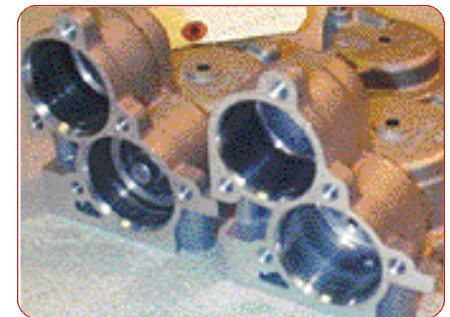
The customer may comment on a delayed engagement into reverse at any time. The condition is not temperature dependent. The cause is a reverse accu-

Bad chamfer on left, good chamfer on right

mulator seal (number 947) that is cut. If the reverse accumulator bore chamfer is cut too deep, the piston seal can travel onto the chamfer area, rolling the seal and cutting it. This is generally found in vehicles built in August and September 2000. Replace the entire accumulator housing (number 944).

Be aware that there is a small chance that you may receive an accumulator housing from SPO with the chamfer cut too deep. There is also the possibility that if you replace the accumulator housing for some other reason, you may introduce the subject condition into the vehicle.

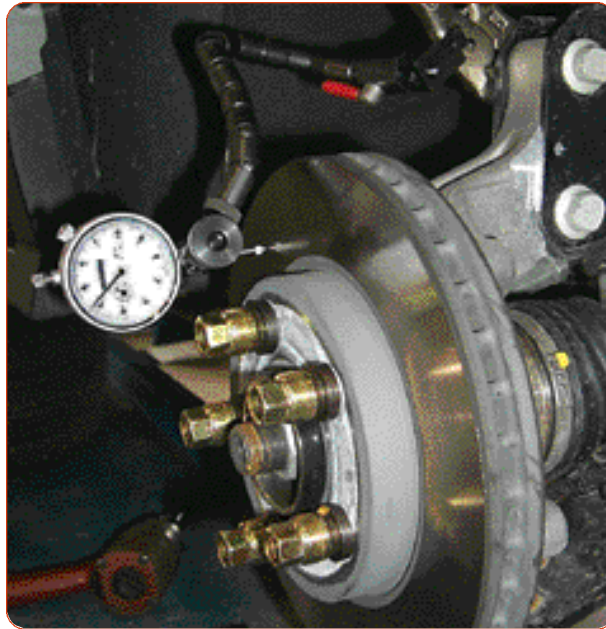
Measuring lateral runout

Any time a rotor is serviced, you should measure LRO after the repair. It's that simple. Mount the rotor to the hub with lug nuts and washers, torqued to specification, and measure the runout. Eliminating runout prevents pulsation.

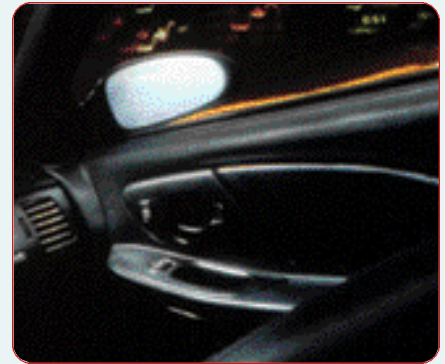
On 2000 - 2001 Chevrolet Monte Carlo models, the door trim pad may be damaged by attempting to remove the power window switch bezel by prying between the door trim panel and the bezel. The bezel does not snap into place and cannot be removed without removing the door trim panel from the door. The power window switch plate, with integral door pull handle bezel, is retained by three fasteners. Once the door trim is removed, two screws located on the metal mounting plate can be removed to separate the two halves of the pull handle bezel. An easily overlooked recessed third screw must be removed from the bottom side of the door pull to release the bezel.

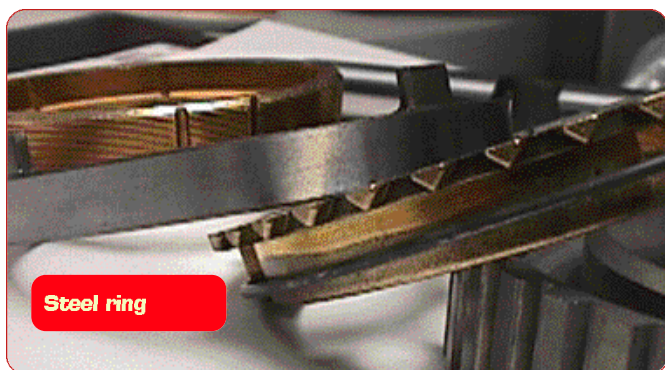
Parts included in p/n 91176201 are the blocker ring, brass cone, steel cone and a three inch diameter steel ring. The three inch diameter steel ring is placed between the blocker ring teeth and the synchronizer hub. Because the inserts and springs are to be discarded, the steel ring is used as a spacer. Failure to

install the steel ring in the correct location will cause a constant mesh of the blocker ring to the sleeve.
