Techline News

OnStar Service Issues

OnStar Service Issues	1
SI 2000 Now Updated Weekly	1
Dealership PC Network Strategies	4
Dinghy Towing -- A Reminder	5
Recognizing OE Batteries	5
New Mid-Size Truck Rear Suspension System	6
Malibu Exhaust Rattle	7
Armrest Lowers Itself During Braking	7
GM Service Clubs, Part 4	7
TAC Tips	8
Bulletins	8

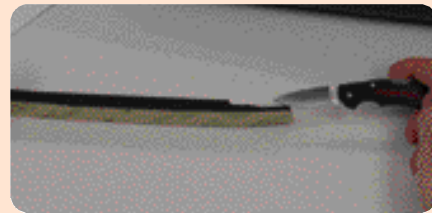
Tapering the foam tape

This condition is corrected by shimming the outboard sides of the armrest.

the cavity in place. Obtain a piece of high density closed cell foam, such as 3M 06370 Scotch Foam Black Vinyl or equivalent. The tape should measure 1 inch wide x 8 inches long x 1/4 inch thick. Taper the last inch of the foam tape to half its thickness to prevent a transition line from showing on the outside of the armrest.
