Generator Operation and Troubleshooting

Techline News

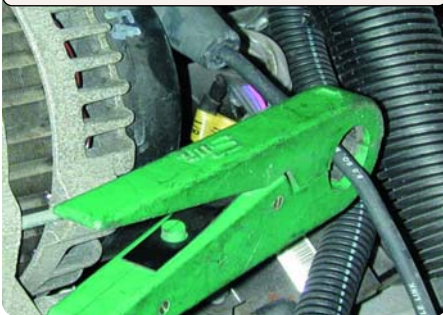
Correct current probe connection at generator

When measuring generator output amperage, make sure you are measuring DC amps in the cable attached to the generator B+ stud and that the current probe is fully

closed. Do not measure generator current at the battery. Also make sure your voltage measurement is correct and that the meter is operating properly.

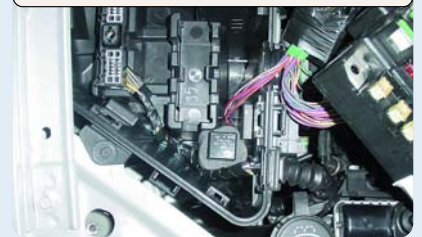
Location of relay in early vehicles

Early production vehicles built before VIN break point 1G6DM57N030105858 have the headlamp washer relay connected to a remote wire harness. It is located beneath the underhood fuseblock in the left front corner of the fuseblock case. For these vehicles, a jumper wire is located in the underhood fuseblock between cavities 67 and 68. This is the location indicated for the headlamp washer relay on the underhood fuseblock label.

The jumper provides battery positive voltage from the HDLP WASH C/B – OPT circuit breaker to the switch side input circuit of the headlamp washer relay.

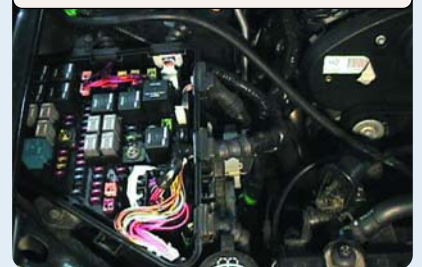
After the VIN breakpoint listed above, the headlamp washer relay is located in the underhood fuseblock. This is the location indicated for the headlamp washer relay on the underhood fuseblock label.

Location of relay in later vehicles

The two configurations are not interchangeable, but are functionally the same. Follow published service manual diagnostics for both configurations. Before attempting to diagnose inoperative headlamp washers, ensure the washer fluid is above the minimum level and the headlamps are ON.

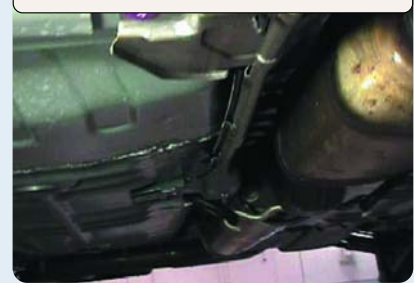
Alternating pressure and vacuum conditions occur inside the wire insulation when the engine is operating and allowed to cool down. Water can literally be pumped inside the insulation by these pressure/vacuum cycles. If the wire insulation is perforated, water can travel inside the wire insulation into the O2 sensor and to the PCM.

Harness in Trough

The harness lies in a trough which may collect water from the HVAC evap core drainage or from the environment.

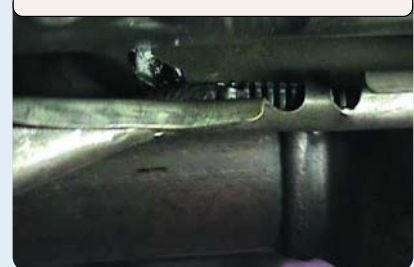
Water damage to these components can cause engine stall, general driveability problems, P0141 (HO2S2 Heater Performance) and others.

Location of damage

Water-damaged components must be replaced. To prevent the problem from recurring, put a length of 5/8-inch hose on the A/C drain elbow. Route the hose down so water drains properly, and secure as necessary with tie straps.
