A monthly publication for GM Dealership Service Professionals

Electronically Controlled Viscous Cooling Fan

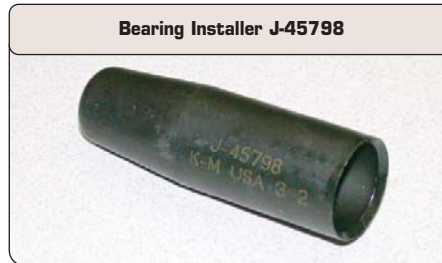
Owners of some 1999-2002 Sierra or Silverado 2500HD and 1500HD pickups may comment about a rattle noise from the steering column, particularly during low speed parking lot maneuvers.

A new stub shaft bearing kit 26099860 has been released to address this issue. The kit contains a bearing, a packet of lubricant and instructions.

TIP: For installation, you must use essential tool J-45798 to avoid damage to

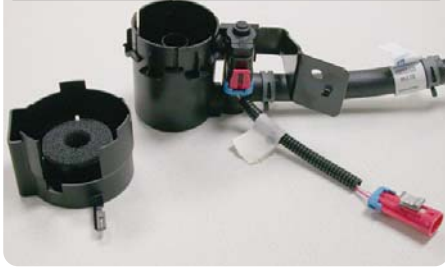
EVAP Vent Hose Assembly with filter

Some 1999-2002 Chevrolet and GMC C/K Pickup models may display a DTC P0446. A restricted or blocked EVAP vent path may occur when a vehicle is operated in a dusty environment, such as farming or mining.

First, perform the diagnostics for P0446 to confirm the cause of the condition. Then replace the EVAP canister vent hose with p/n 15086426. This assembly has enhanced filtering and a removable, cleanable filter element.

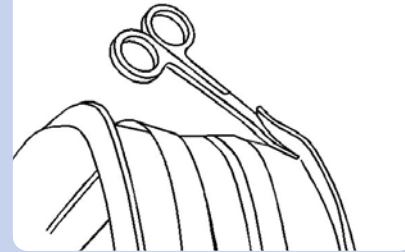
Cutting a relief notch

The cause is increased friction in the front window run channel due to a pinch point in the rubber. GM Service Bulletin 02-08-64-004 has just been released to communicate a field fix to relieve the pinch point by cutting a relief notch in the rubber run channel.

In cases where the forward area of rubber run channel is worn, replace the rubber channel with a new part. A new notched rubber run channel was released into Tracker production in March, 2002, and will soon be released as a GM service part. Until the notched service part becomes available, it is a simple procedure to cut a relief notch in the new part according to the instructions in the service bulletin.

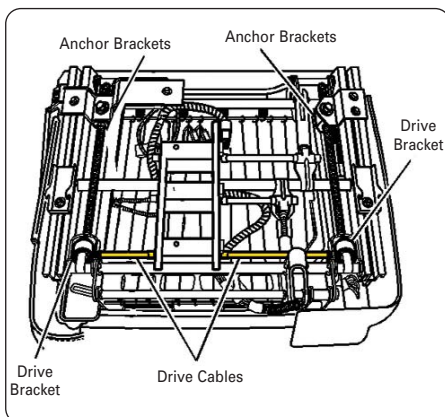
This is an indication that one of the drive cables has disengaged. The horizontal drive has two cables that lie between the motor and a drive screw on each side of the adjuster. If either cable is bent, an end will disengage from the motor or the drive screw.

Remove the cable that was bent and examine it for any damage. Replace a damaged cable when parts become available. Examine all the drive cables to ensure that they are straight.
