Terminal Repair Kit Update

Techline News

Contents

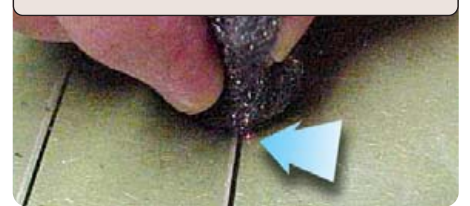
Demonstrating spark in laboratory

This condition may result from break(s) in the rear defogger grid. Begin by inspecting the grid for scratches. A fine crack may develop over time and may not be readily visible. On Impalas, a likely location is one of the three lower grid lines, on the driver's side, approximately 385 mm (15 in.) from the inboard edge of the bus bar. No specific locations have been identified on the Monte Carlo.

TIP: A diagnostic tool may be made by loosely twisting steel wool into a 2-inch strand. With the rear defogger turned on, pass the steel wool LIGHTLY along the grid lines. When the steel wool bridges the gap in the grid, it will emit a visible spark, and will eliminate the static in the radio.

If you can locate a break in the grid, repair it according to SI procedures, following this path:

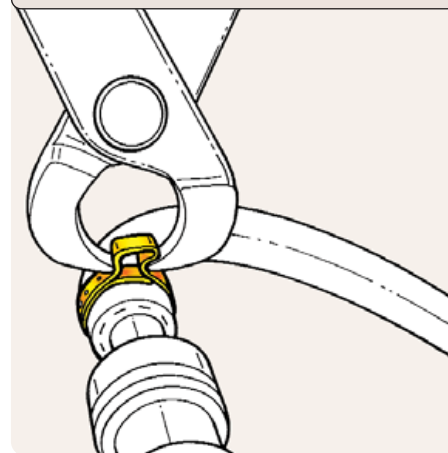
Crimping Oetiker clamp

- be missing
- be installed but not crimped
- be incorrectly crimped.

You must inspect the hose fittings, install missing clamps, and crimp/recrimp all hose clamps using J-43218 or equivalent Oetiker clamp crimping tool, to ensure that all four clamps are fully crimped.

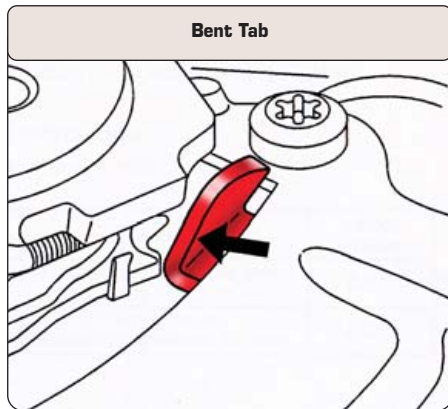
Windshield Wipers Park in the Vertical Position

Owners of some 2002 Buick Century and Regal, Chevrolet Impala and Monte Carlo, Oldsmobile Intrigue, or Pontiac Grand Prix may comment that the windshield wipers park in the vertical (outwipe) position.

This may be caused by a bent park tab on the windshield wiper motor bracket.

If the tab is bent, you will need to install a new wiper motor crank arm 12494832 and motor bracket service kit 88958149 (88958260 in Canada). Instructions are included in bulletin 02-08-43-002.
