A monthly publication for GM Dealership Service Professionals

## Contents

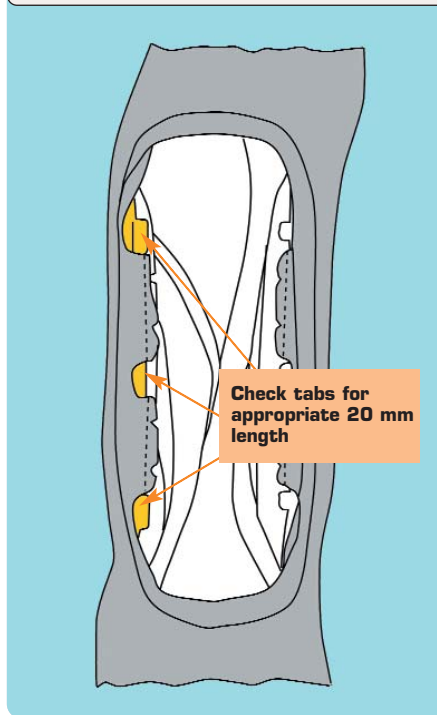
View of driver's seatback with Side Impact Airbag removed

On a 2001 Monte Carlo equipped with leather seating, a gap may develop between the driver's seat back trim and the Side Impact Airbag (SIAB). This condition is caused by the lack of tension between the seat trim and the airbag bezel (white plastic cup attached to the seat frame).

Several improvements were implemented midway through the 2001 model year to eliminate this condition. To correct a vehicle exhibiting this condition, check the bezel slot width (slots located on the forward edge of the bezel), and replace the part if it is 5/16-inch (7.94 mm) or greater. The new bezel, part number 88951498, has a slot width of 3/16-inch (4.76 mm).

Next, measure the tabs on the seat trim plastic reinforcement that engage into the revised bezel slots, located on the forward edge of the seat trim opening, to determine if the vehicle has the revised seat trim. The revised seat trim has a tab length of 20 mm. The seat trim should be replaced if the tab is any shorter than this.

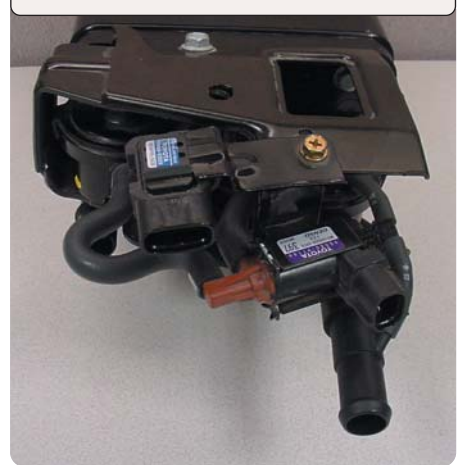
EVAP Pressure Switching Valve

The pressure switching valve may be defective. You should hear a clicking noise when you command the PSW on and off using the Tech 2. If you cannot hear the valve click, make sure there is 12 volts at the solenoid, and that the PCM is supplying the ground to the circuit when you command the valve on. If the power and control sides of the solenoid are working properly, replace the pressure switching valve.

The EVAP system Pressure Switching Valve is attached to the vapor canister by a single screw. Do not replace the complete canister assembly. The PSW can be replaced separately. The part number for the valve is 94859365.

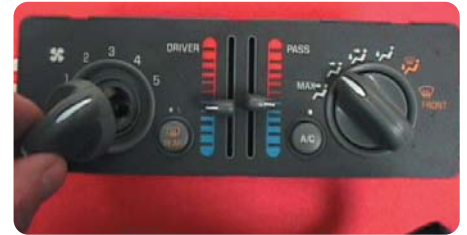
On 1999-2002 Pontiac Grand Am and Grand Prix, the mode control or blower speed control knob is replaceable individually, if the knob becomes stripped or broken. It is not necessary to replace the entire control head in these cases.

1999-2002 Grand Prix	9363337
1999-2000 Grand Am	9363337
2001-2002 Grand Am	9380265
