Do You Really Need a VCI Number ?

Submission of all OBDII P-Codes with Warranty Claims Will Enhance Product Quality Feedback

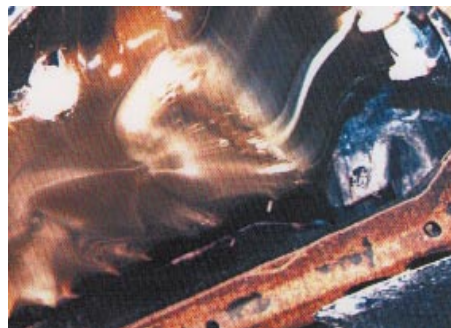
Water in oil, resulting from extreme short-trip driving, photographed through a transparent oil pan.

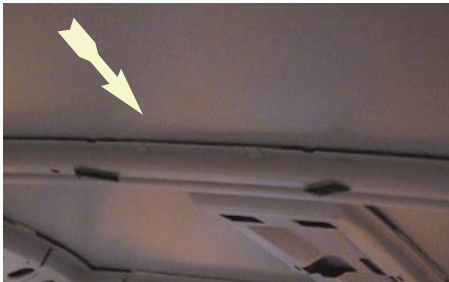
Roof Bow

els, a slight roof depression located over the B-pillar may be noticeable. This depres-

sion in the roof is caused by the sound deadening material adhering to the roof.
