Compression Sense Ignition

An all-new 2.2L engine (RPO L61, VIN F) is used in Pontiac Sunfire and Grand Am, Oldsmobile Alero and Chevrolet Cavalier for 2002. This is an aluminum 4-cylinder engine with four valves per cylinder. It uses a speed density fuel injection system and a waste spark electronic ignition system.

Compression Sense Ignition	1
Service Information: New and Improved	1
Class 2 Corner	2
Corvette Magnetic Selective Ride Control	4
Theft Deterrent Application Update	4
Airbag Zoning	5
Tech Tips	
Carpet Separates from Sill Molding	5
A/C Liquid Line Rubbing	5
Wheel Speed Sensor Clips	6
Cardan Joint Lubrication	6
Mildew Odor or Wet Carpet	6
Pontiac Vibe Service Tips	7
Third Door Handle	7
Bulletins	8

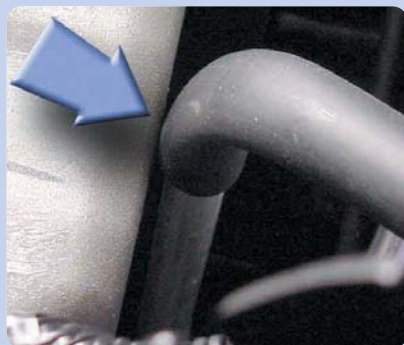
A/C Liquid Line Rubbing

On some 2002 Buick Century and Regal vehicles, the A/C liquid line may rub through at the transaxle side cover pan. This may not occur until the vehicle has 20,000 miles (32,200 km) on it.

TIP: To avoid this condition, check this area during new vehicle predelivery inspection.

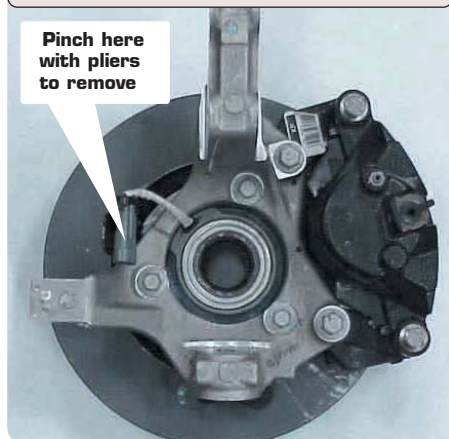
Connector clipped to bracket

Pinch here with pliers to remove

Early production used a stainless steel (SS) clip on the wiring connector, which could be removed from the bracket simply by pulling. Later production uses a plastic W-clip, which requires ordinary pliers for removal.

TIP: Do not replace either style of clip with the other. They are not interchangeable.

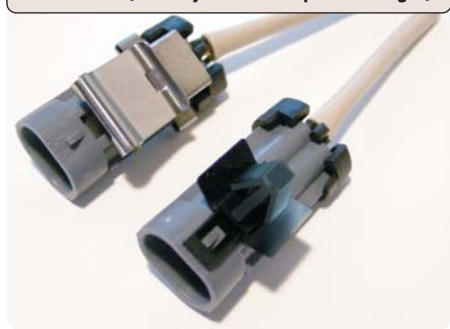
12429204 (old style with SS clip-top left) and 12429205 (new style with W-clip-bottom right)

When you replace a wheel speed sensor/wheel bearing assembly (for bearing noise, WSS code, etc.), you must determine which type of sensor is on the vehicle and replace it with the same kind. Check the parts book for details.

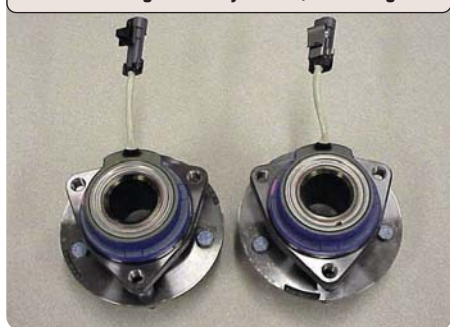
New bearing assembly on left, old on right

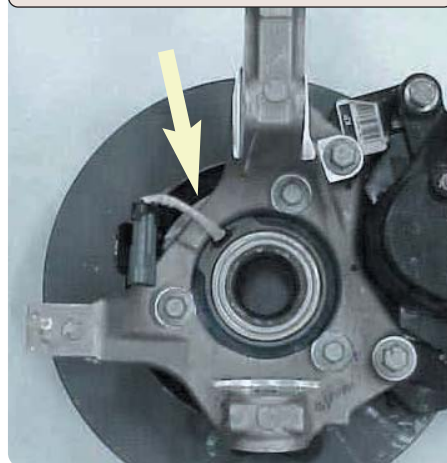
At the time the clips were changed, the mounting orientation of the sensor was also changed. Sensors with the old SS clip were mounted with the wire lead near the 6:00 o'clock position. New sensors with the W-clip are mounted with the wire lead near the 2:00 or 10:00 o'clock position, depending on which side of the vehicle it's mounted. This moves the lead away from the lower ball joint attachment, as shown in the accompanying photo.

Sensor wire lead location with the new W-clip

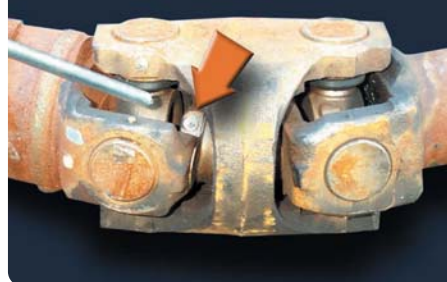
Some 1994-2002 trucks, such as the Chevrolet S-10 and GMC Sonoma extended cab with L35 V-6, use a propeller shaft that has double cardan type U-joints. A similar shaft is used as a service replacement on 1999-2002 2-wheel drive, automatic, extended cab Sierra and Silverado trucks. Premature wear of the cardan joint ball and socket can result in noise and vibration at road speeds.

Premature wear may be caused by inadequate lubrication. A grease passage in each cross yoke should be lubricated at normal chassis lubrication intervals.

Cardan Joint Cross Yoke Grease Fitting and Needle-Type Applicator

You will need a needle-type grease gun adapter such as Plew's/Stant 99-009 or 05-025, available locally. Use Chassis Lubricant, P/N 12377985 (88901242 in Canada) or equivalent. The slip yoke should also be

greased at the zerk fitting. SI 2000 will be updated to include propshaft lubrication service.

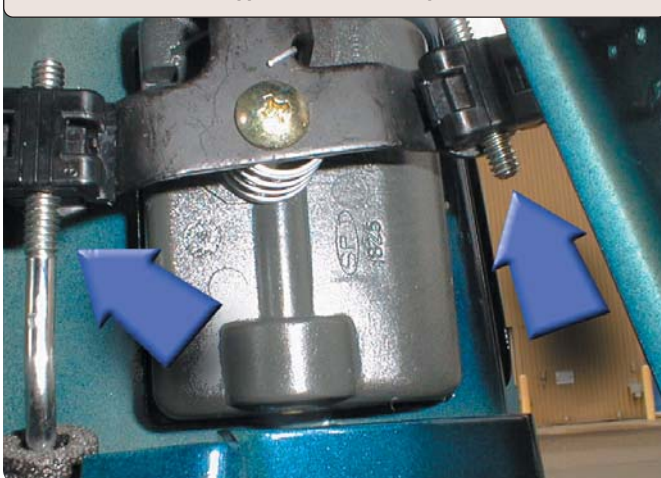
Owners of some 1996-2002 extended cab S-10 and Sonoma pickups may comment on excessive effort or breaking of the third door handle. This may be caused by improper placement of the attachment clips and/or binding at the top latch.

Upper and lower rod clips

is not bound against the latch. If it is, you must push the door inboard to release the latch. To correct a bound latch, adjust the striker by loosening two bolts at the top, so the striker is centered in the latch. Do not bend the striker.

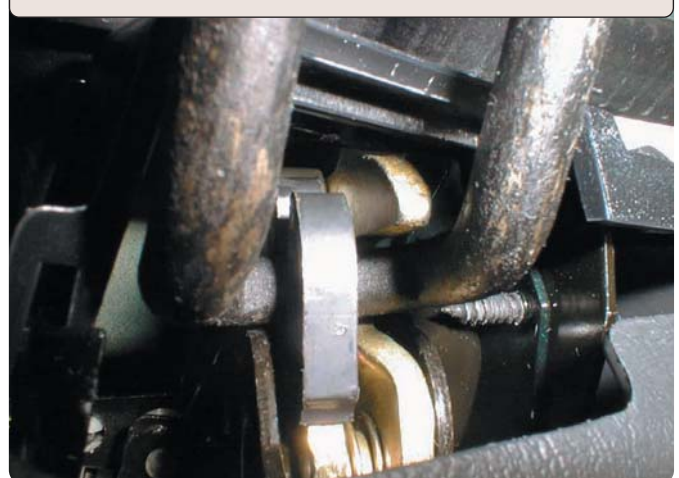
Latch and striker
