New Levels of Precision in Wheel Alignment

Techline News

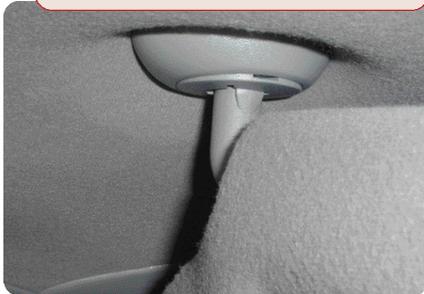
If you use the incorrect removal procedure or the incorrect tools, you will break the visor or cause cosmetic damage to the plastic parts.

Pivot slot aligned with visor slot

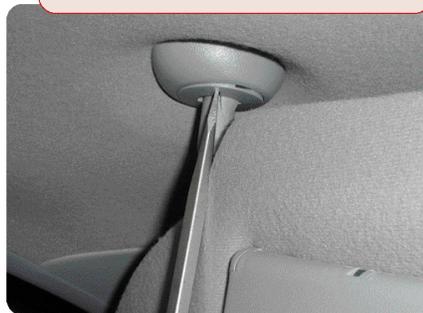
Screwdriver in slot.

bezel on the headliner. Push the visor to the headliner while maintaining the screwdriver in the correct position and continue rotating the visor toward the side window.

Pull the retainer from the bezel and disconnect the electrical wires if equipped with lighted visor vanity mirrors.

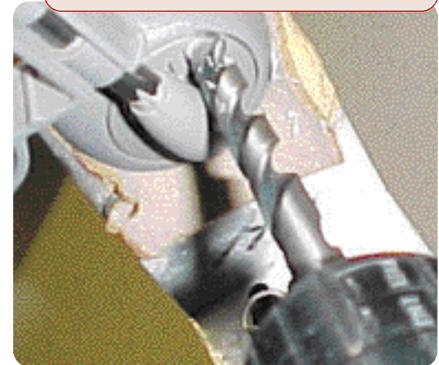
Emergency removal using 3/8-inch drill

If the recommended removal does not work, it will be necessary to destroy the visor pivot.

Use a 3/8-inch drill bit to drill out the pivot as shown in the photo. This will destroy the triangular lock in the bezel. Then, rotate the visor toward the side window to remove the pivot from the

Obtain a replacement visor and bezel and install.

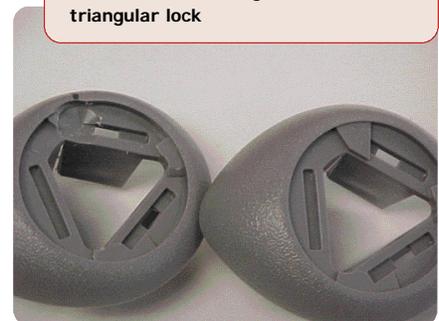
Bezel on left showing drilled out triangular lock

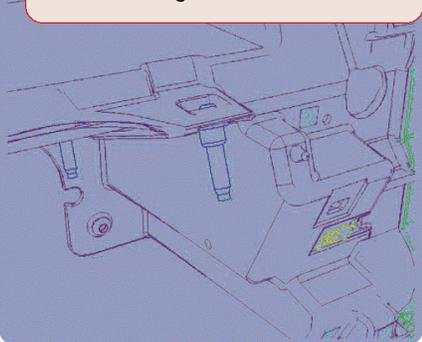
Steering column fastener installed in mag beam

But when you loosen the steering column fasteners, DO NOT simply loosen the retaining nuts. In many cases, the nut and stud come out as a unit, leaving the square nut stranded in the depression on the top side of the mag

beam. Then, when you attempt to install the stud, the square nut will be pushed out of position. It may then be necessary to loosen and move the instrument panel to gain access to the square nuts.

Here's the proper method for loosening the nuts. First, install a 13 mm crowfoot wrench to the nut. Then, install a number 7 inverted Torx socket to the bottom of the stud. Use the Torx socket to hold the stud while you loosen the nut with the crowfoot wrench. This prevents the stud from unscrewing from the square nut. Now, when you lower the steering column, the stud and square nut remain in position on the magnesium beam.

When you install the steering column, torque the retaining nuts to 27 N.m (20 lb ft).
 - Thanks to Jim Haist

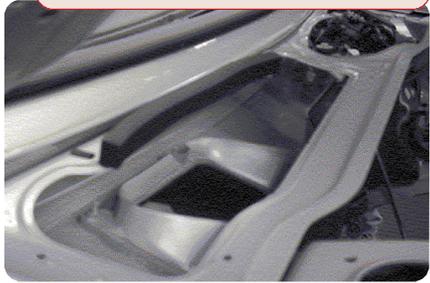
Location of foam

about a mildew odor, windshield fogging, or wet carpet on the passenger side. And

in ambient temperatures below 32° F, the blower may not operate due to ice.

The foam water dam under the black beauty panel may be mis-positioned, missing, or not adhered properly.

Install 25 mm foam.
 - Thanks to Ray Romeo

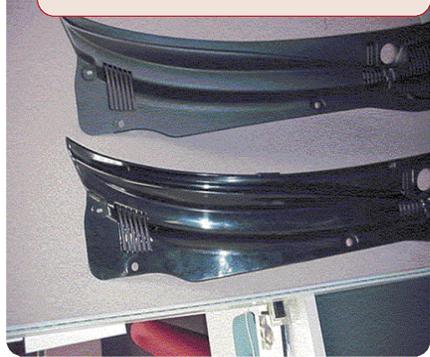
Old style panel, top
 New style panel, bottom
