A monthly publication for GM Dealership Service Professionals

## TECH Link

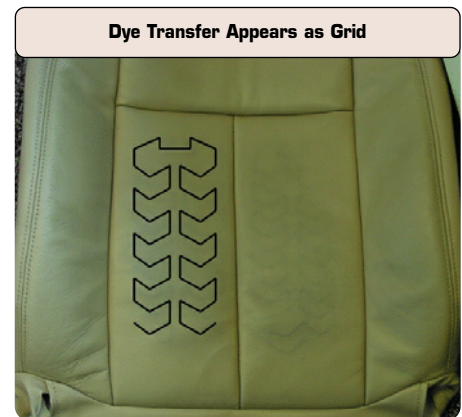
Some leather seat covers have been returned in which the heated seat grid shows through. It appears that the leather seat cover has been burned by the heater grid. However, this is not the case.

This condition is actually caused by dye transfer from the passengers' clothing, which discolors the leather and is more noticeable on lighter colored leather. Dye transfer is an industry-wide concern and will occur on any leather product. Blue jean material is notorious for leaving blue dye on leather.

Cleaning the leather on a regular basis with mild soap and water as recommended in the owner's manual is the only prevention. Just like the paint on the exterior of the vehicle, regular maintenance will increase the life of the product.

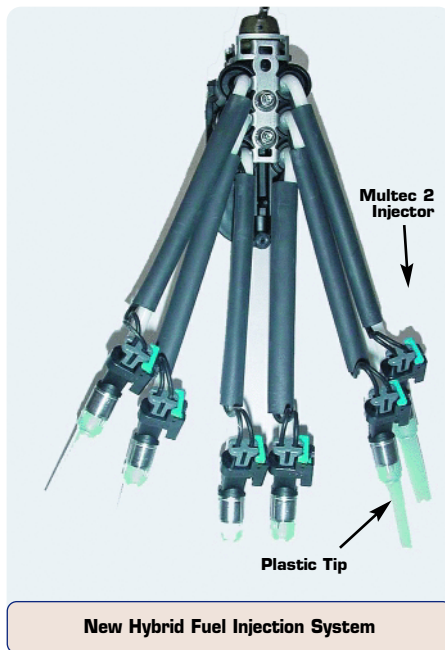
**New Hybrid Fuel Injection System**

When you remove the engine's upper intake plenum, you will notice the differences. The new design uses the fuel meter body from the SCPI injection system. However, the SCPI fuel injector and poppet nozzle have been replaced with the state of

the art Multec 2 fuel injector. A new bracket is used to retain the fuel meter body to the intake manifold.

Service of the unit involves some careful consideration. At this time, no cleaning has been recommended for the new system equipped with Multec 2 injectors.

**IMPORTANT:** Service bulletin 00-06-04-003 was written to clean and unstick poppets on SCPI systems. Do NOT use procedures in this bulletin on Multi-port Flexible Injection systems or permanent damage to the unit may result.
