Do You Really Need a VCI Number ?

Submission of all OBDII P-Codes with Warranty Claims Will Enhance Product Quality Feedback

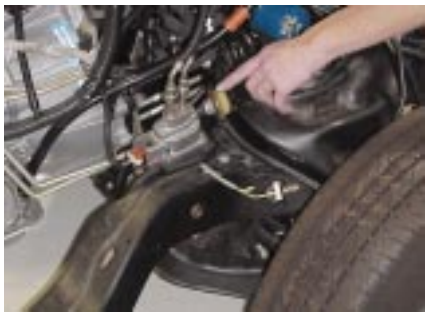
Flexible Fuel Sensor

To measure the true ethanol alcohol percentage and fuel temperature needed for proper engine operation, the L43 engine uses a flexible fuel sensor. It's located on the top of the right side frame rail, behind the right front upper control arm. All fuel delivered to the engine passes through the flex fuel sensor for ethanol measurement.
