Generator Operation and Troubleshooting

Techline News

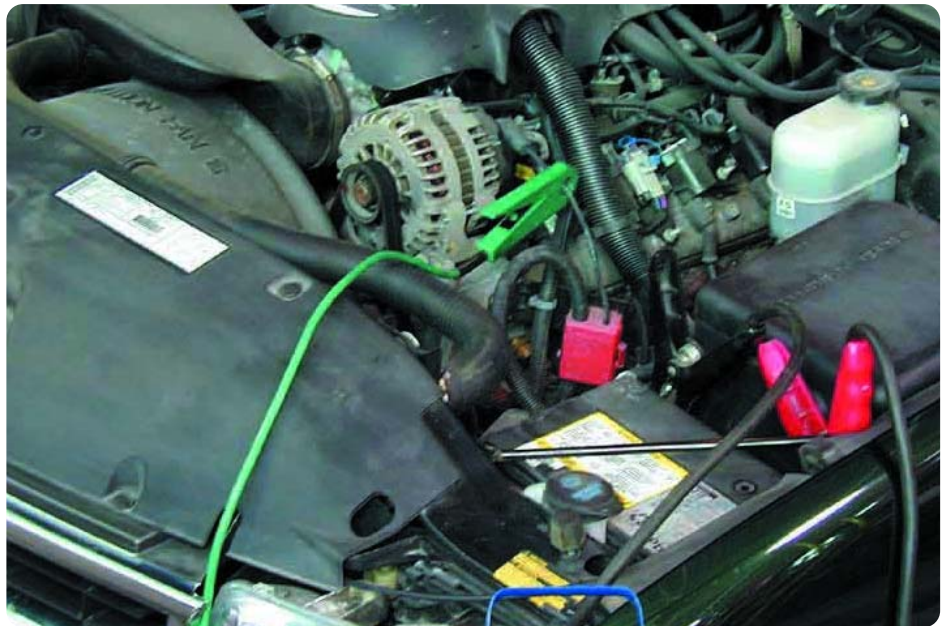
When measuring generator output amperage, make sure you are measuring DC amps in the cable attached to the generator B+ stud and that the current probe is fully

closed. Do not measure generator current at the battery. Also make sure your voltage measurement is correct and that the meter is operating properly.

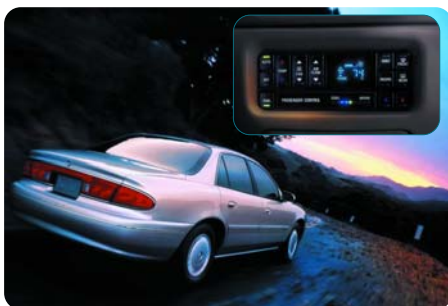
Some customers may comment that the AUTO indicator turns off under certain conditions.

1. When the temperature selector is run to the extreme in either direction (60°F/16°C or 95°F/35°C), the HVAC system will cease regulating the temperature. Instead, it outputs full cold or full hot. This defeats the AUTO function, so the indicator turns off.
2. Manually selecting a fan speed by pressing the + or - button will defeat the AUTO function, so the indicator turns off.
3. Similarly, manually selecting an air distribution path (just IP, just floor, etc.) will defeat the AUTO function, so the indicator turns off.

In all three of these cases, it is normal for the indicator to turn off, and no repair or component replacement is necessary.
