A monthly publication for GM Dealership Service Professionals

Electronically Controlled Viscous Cooling Fan

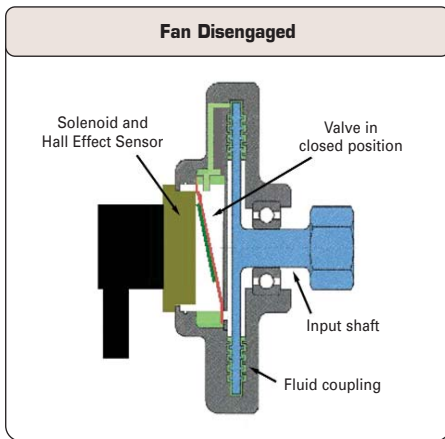
Review of Conventional Thermostatic Fan Clutch

The conventional thermostatic clutch is a fluid coupling, belt-driven by the engine. The amount of fluid in the coupling is controlled by a bimetallic coil spring attached to a valve. More fluid is admitted into the coupling at higher temperatures, causing the fan rotation to increase. At lower temperatures, the spring closes the valve, decreasing fluid in the coupling, and the fan rotation decreases.

Fluid is pumped from a reservoir in the fan clutch into the coupling by the action of the fan shaft.

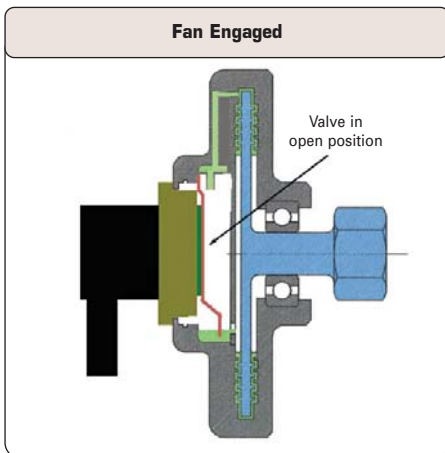
EV Fan Operation

The EV fan clutch also operates by controlling the amount of fluid admitted into the coupling. But instead of a bimetallic spring, the valve is operated by an electrical solenoid.

The solenoid is controlled by a solid-state device, operated by a pulse-width-modulated (PWM) signal from the PCM. As the commanded state of the fan clutch increases, so does the ON time of the relay.
