New Levels of Precision in Wheel Alignment

Techline News

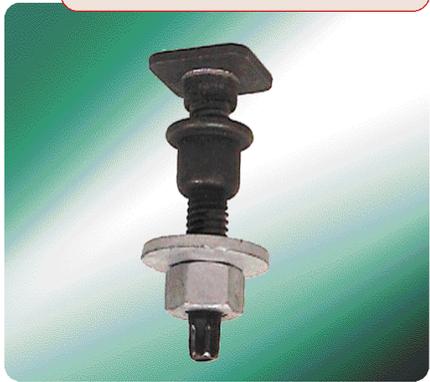
Steering column fastener

consisting of a headless stud, a square nut at the top, and a conventional nut at the bottom.

The square nut fits into a square depression in the magnesium beam and the steering column is installed onto the stud. Then, a nut is driven onto the stud, retaining the steering column. Depending on carline, there may be four or six of these studs.

But when you loosen the steering column fasteners, DO NOT simply loosen the retaining nuts. In many cases, the nut and stud come out as a unit, leaving the square nut stranded in the depression on the top side of the mag

beam. Then, when you attempt to install the stud, the square nut will be pushed out of position. It may then be necessary to loosen and move the instrument panel to gain access to the square nuts.

Here's the proper method for loosening the nuts. First, install a 13 mm crowfoot wrench to the nut. Then, install a number 7 inverted Torx socket to the bottom of the stud. Use the Torx socket to hold the stud while you loosen the nut with the crowfoot wrench. This prevents the stud from unscrewing from the square nut. Now, when you lower the steering column, the stud and square nut remain in position on the magnesium beam.

When you install the steering column, torque the retaining nuts to 27 N.m (20 lb ft).
 - Thanks to Jim Haist
