Terminal Repair Kit Update

Techline News

Contents

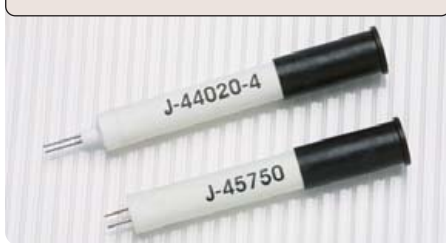
New Release Tools

The Bosch .64 terminal is not included in the Terminal Repair kit. It is serviced through GMSPO with a terminated lead, p/n 22688141. You must splice the replacement lead to the wiring harness using approved splicing techniques. Use the J-44020-A terminal release tool to release the terminal from the connector.

A J-45750 terminal release tool has also been added for Bosch terminals used on fuel injectors and Bosch sensors.

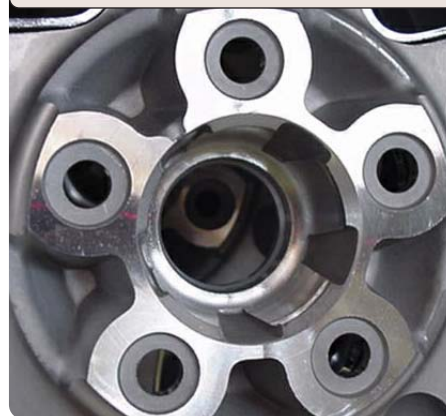
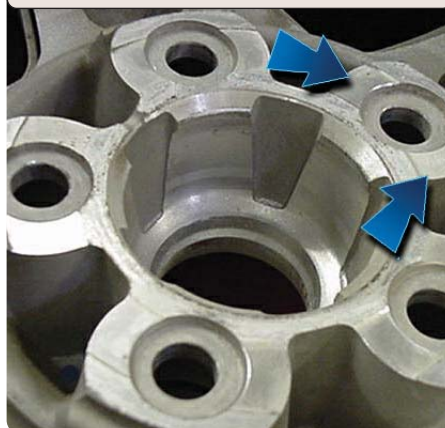
New flat face wheel

Old style wheel

assembly (knuckle, hub, rotor, wheel assembly). This design also includes a new finish coating on the bearing studs and wheel lug nuts.

Important – the 2003 model year aluminum wheels cannot be used to back-service past model vehicles (2002, 2001 etc.). Part number changes and labeling have occurred for 2003 model year aluminum wheels, bearing studs and lug nuts.

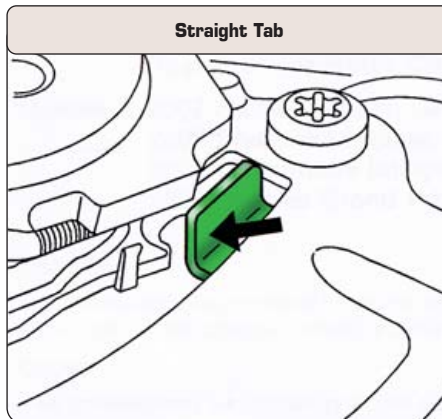
This may be caused by a bent park tab on the windshield wiper motor bracket.

If the tab is bent, you will need to install a new wiper motor crank arm 12494832 and motor bracket service kit 88958149 (88958260 in Canada). Instructions are included in bulletin 02-08-43-002.

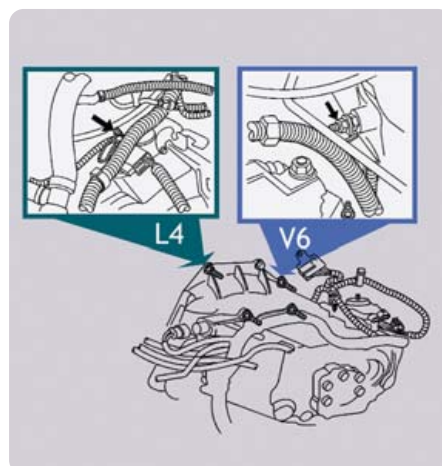
This condition may be caused by a loose G103 ground connection. To correct it, refer to recently released bulletin 02-08-45-002 and follow the procedure to install a flat washer (p/n 15650963) to the G103 ground stud to gain proper eyelet clamping.
